# Lenovo Flex System x240 Compute Node Installation and Service Guide

Machine Types: 7162, 2588

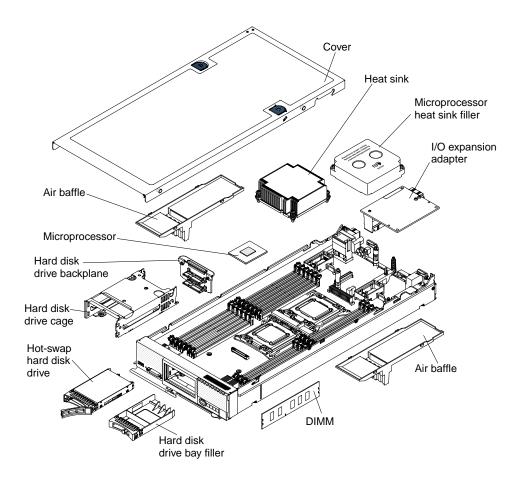
The following illustration shows the major components of the compute node.

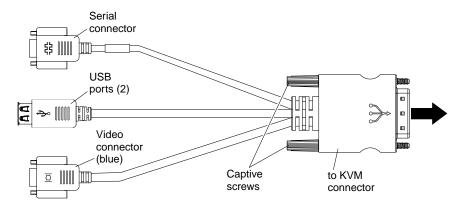
Use the console breakout cable to connect external I/O devices to the compute node. The console breakout cable connects through the KVM connector (see "Compute node controls, connectors, and LEDs" on page 12). The console breakout cable has connectors for a display device (video), two USB connectors for a USB keyboard and mouse, and a serial interface connector.

The following illustration identifies the connectors and components on the console breakout cable.

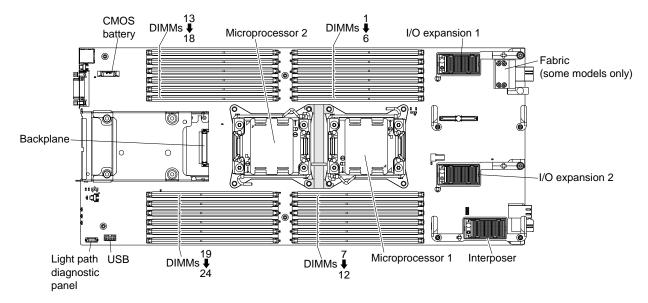
Use this information to locate compute node system-board components and connectors for optional devices.

The following illustration shows the system-board components, including connectors for user-installable optional devices, in the compute node.

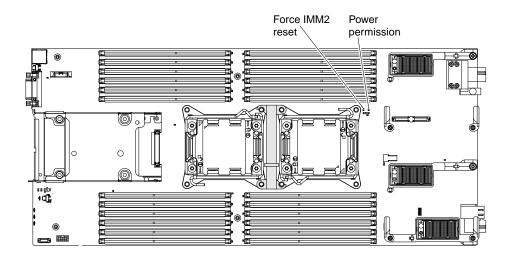
The following illustration shows the locations of the jumpers on the system board.

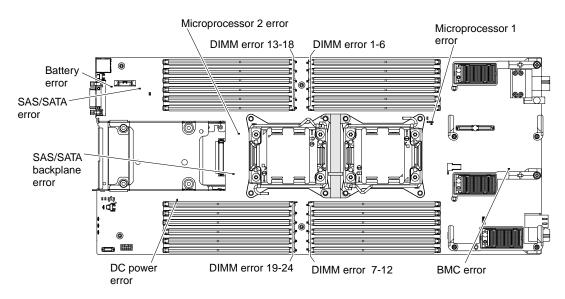
The following illustration shows the locations of the LEDs on the system board.

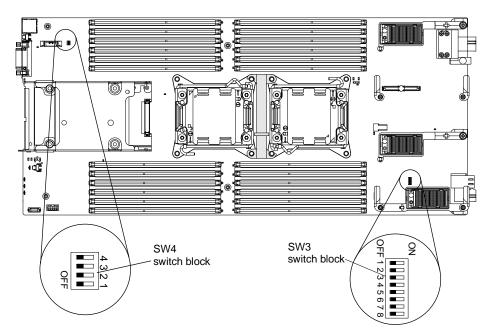
The following illustration shows the location of the switch block on the system board.

The following table describes the functions of the switches on switch blocks SW3 and SW4.

Switch number	Description	Definition
SW3-1	Password override	The default position is Off. Changing this switch to the On position overrides the power-on password.
SW3-2	Trusted Platform Module (TPM) physical presence	The default position is Off. Changing this switch to the On position indicates a physical presence to the TPM.
SW3-3	Real time clock (RTC) reset	The default position is Off. Changing this switch to the On position resets the RTC. A momentary toggle is all that is required. To avoid excessive CMOS battery drain, do not leave this switch in the On position.
SW3-4	Boot backup IMM2	When the switch is in the default Off position, the compute node will boot by using the primary IMM2 firmware. When the switch is in the On position, the compute node will boot by using a backup of the IMM2 firmware.
SW3-5	Boot backup UEFI	The default position is Off. Changing this switch to the On position forces the compute node to boot from the backup UEFI image.

- 5. Locate the boot backup UEFI switch on the switch block and change the switch to the On position (see "System-board switches" on page 18).
- 6. Replace the cover and reinstall the compute node in the Flex System chassis (see "Installing the compute node cover" on page 678 and "Installing a compute node in a chassis" on page 673).

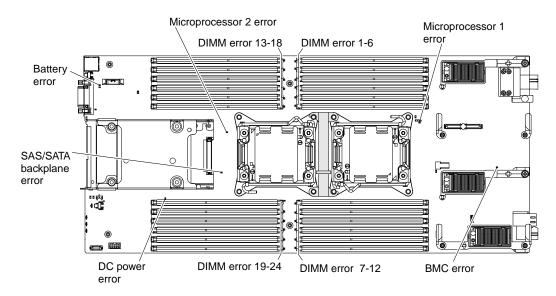
The following illustration shows the locations of the light path diagnostics LEDs on the system board.

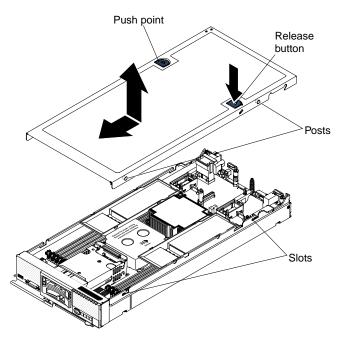
To remove the compute node cover, complete the following steps:

- Step 1. Press on the release button and the push point at the same time and slide the cover toward the rear of the compute node.
- Step 2. Lift the cover away from the compute node.

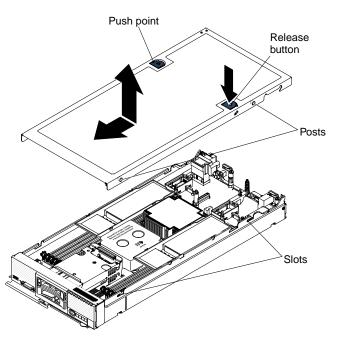
- Step 1. Carefully lay the compute node on a flat, static-protective surface, orienting the compute node with the bezel pointing toward you.
- Step 2. Orient the cover so that the posts on the inside of the cover slide into the slots on the compute node.

- Step 3. Hold the front of the compute node and slide the cover forward to the closed position, until it clicks into place.
- Step 4. To install a system service label, align the label on the cover, remove the backing, and press the label on the cover.

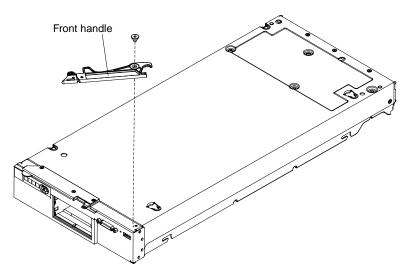
To remove the front handle, complete the following steps.

- Step 1. Locate the screw that attaches the handle to the compute node.
- Step 2. Using a T15 Torx screwdriver, remove the screw from the front handle and save the screw in a safe place. Use the same screw when you install a front handle.

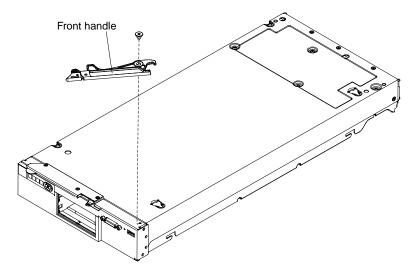
To install the front handle, complete the following steps.

- Step 2. Align the hole in the handle with the hole on the compute node where the handle is installed.
- Step 3. Using a T15 Torx screwdriver, install the screw that secures the handle. Install the screw that you removed when you removed the handle.

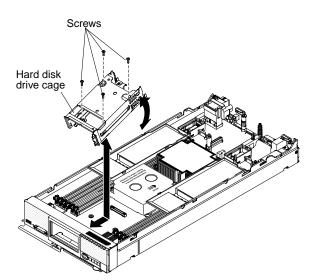
To install the hard disk drive cage, complete the following steps.

- Step 1. Remove the cover (see "Removing the compute node cover" on page 676).
- Step 2. Position the cage in the bezel at an angle and rotate the cage into position on the system board.
- Step 3. Align the cage with the screw holes on the system board.
- Step 4. Using a T8 Torx screwdriver, insert the four screws and secure the cage in the compute node.
- Step 5. Install the hard disk drive backplane (see "Installing the hard disk drive backplane" on page 700).
- Step 6. Insert the hot-swap hard disk drives and hard disk drive bay fillers.

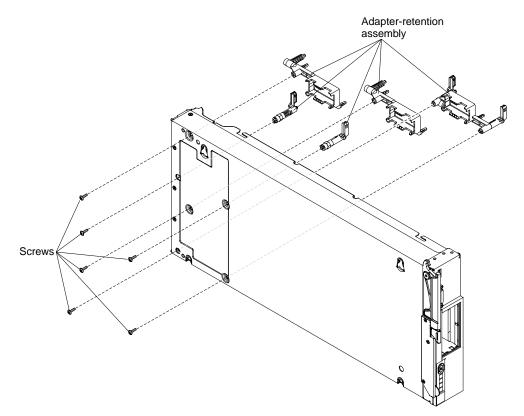
The adapter-retention assembly consists of five separate parts. You can replace only the parts that you choose and save the unused parts for future use.

- Step 1. Remove the cover (see "Removing the compute node cover" on page 676).
- Step 2. Remove the air baffles.
- Step 3. If necessary, remove the I/O expansion adapters (see "Removing an I/O expansion adapter" on page 704).
- Step 4. Carefully place the chassis on its side with the front handle side up.
- Step 5. Using a T10 Torx screwdriver, remove the six screws that secure the adapter-retention assembly.
- Step 6. Lift the adapter-retention assembly from the system board.
- Step 7. Carefully return the chassis to the bottom-side-down orientation.

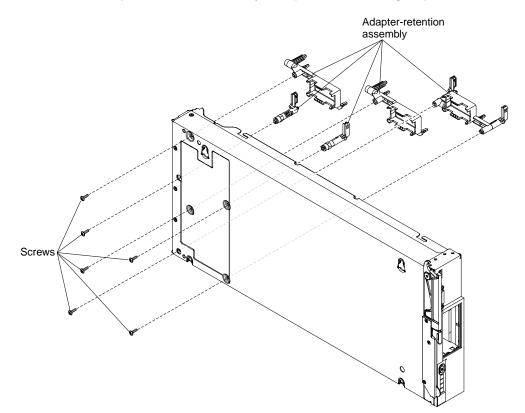
To install the adapter-retention assembly, complete the following steps.

- Step 1. Remove the cover (see "Removing the compute node cover" on page 676).
- Step 2. Remove the air baffles.
- Step 3. Carefully place the chassis on its side with the front handle side up.
- Step 4. Align the adapter-retention assembly on the system board.
- Step 5. Using a T10 Torx screwdriver, install the screws that secure the adapter-retention assembly.
- Step 6. Carefully return the chassis to the bottom-side-down orientation.
- Step 7. Install the I/O expansion adapters, if you removed them (see "Installing an I/O expansion adapter" on page 705).
- Step 8. Install the air baffles.

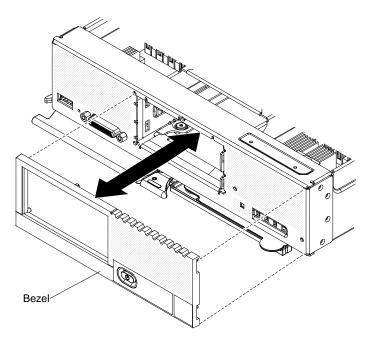
To remove the bezel, complete the following steps.

- Step 1. Use a flat-blade screwdriver to carefully pull the bezel from the compute node.
- Step 2. Lift the bezel from the compute node.

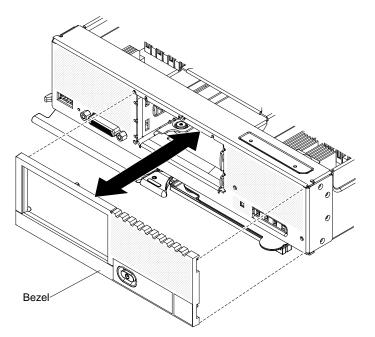
To install the bezel, complete the following steps.

- Step 1. Position the bezel on the front of the compute node.
- Step 2. Press the bezel securely against the chassis.

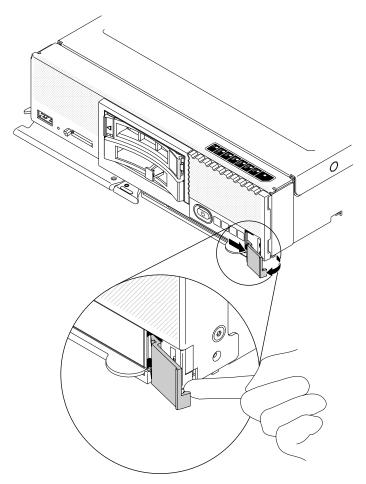
To remove the ID label plate, complete the following steps.

- Step 1. Using a finger nail or flat-blade screwdriver under the lower outside corner of the label plate, pull the outer edge of the ID label plate away from the compute node front panel.
- Step 2. Rotate the ID label plate away from the front panel; then, remove the ID label plate.

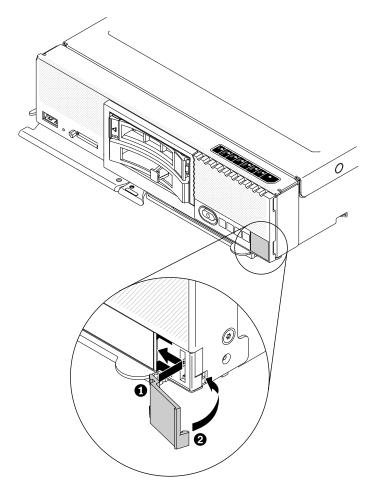
To install the ID label plate, complete the following steps.

- Step 1. Place the clips on the ID label plate into the slots on the compute node front panel.
- Step 2. Rotate the outer edge of the ID label plate toward the compute node front panel; then, press the ID label plate securely against the front panel.

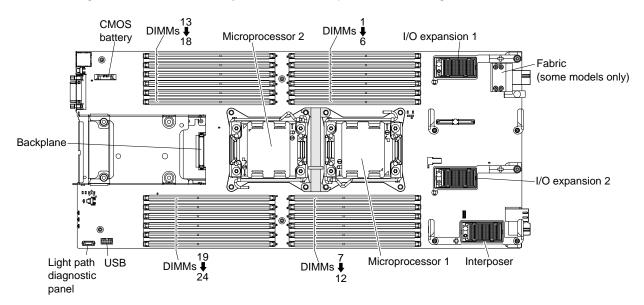
The compute node has a total of 24 dual inline memory module (DIMM) connectors. The compute node supports low-profile (LP) DDR3 DIMMs with error-correcting code (ECC) in 2 GB, 4 GB, 8 GB, 16 GB, and 32 GB capacities.

The following illustration shows the system-board components, including the DIMM connectors.

The memory is accessed internally through four channels. Each memory channel has three DIMM connectors for each microprocessor (six total). Each channel can have a maximum of eight ranks. The following table lists the memory channels and shows which DIMM connectors are in the channel for each microprocessor.

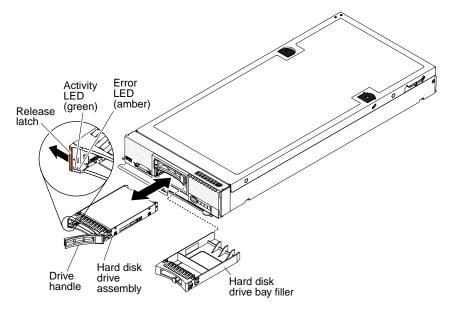
To remove a hot-swap hard disk drive, complete the following steps.

- Step 1. Press the release latch (orange) on the hard disk drive to release the drive handle.
- Step 2. Pull the release handle to remove the drive from the bay.

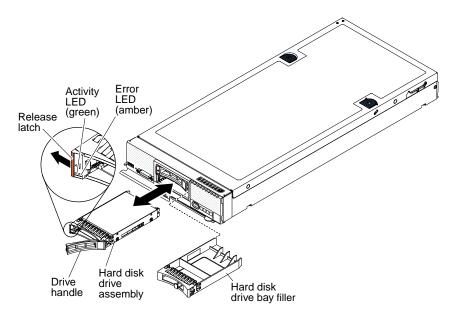
The compute node has two SAS or SATA hard disk drive bays for installing hot-swap hard disk drives, such as hot-swap SAS hard disk drives. One hard disk drive might already be installed in the compute node. If the compute node is equipped with one hard disk drive, you can install an additional drive. The compute node supports using RAID 0 or RAID 1 when two hard disk drives of the same interface type are installed. See "Configuring a RAID array" on page 34 for information about RAID configuration.

To install a hot-swap hard disk drive or hard disk drive bay filler, complete the following steps.

- Step 1. Identify the hard disk drive bay in which you plan to install the hot-swap hard disk drive.
- Step 2. If a hard disk drive bay filler is installed, remove it from the compute node by pulling the release lever and sliding the filler away from the compute node.
- Step 3. Touch the static-protective package that contains the hot-swap hard disk drive to any *unpainted* metal surface on the Flex System chassis or any *unpainted* metal surface on any other grounded rack component; then, remove the hard disk drive from the package.
- Step 4. Open the release lever on the hot-swap hard disk drive and slide the drive into the bay until it is firmly seated in the connector.
- Step 5. Lock the hot-swap hard disk drive into place by closing the release lever.
- Step 6. Check the hard disk drive status LEDs to make sure that the hard disk drive is operating correctly.

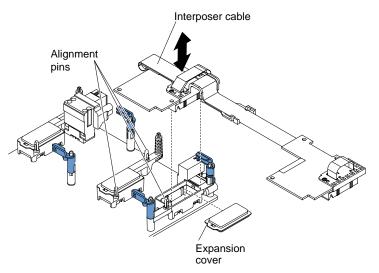
To remove an interposer cable, complete the following steps.

- Step 1. Remove the cover (see "Removing the compute node cover" on page 676).
- Step 2. Locate the interposer connector (see "System-board connectors" on page 17).
- Step 3. If an I/O expansion adapter is installed over the interposer connector, remove it (see "Removing an I/O expansion adapter" on page 704).
- Step 4. Lift the interposer cable from the connector and remove the cable from the compute node. You might find it helpful to rock the cable back and forth to disengage the cable.
- Step 5. If necessary, install the I/O expansion adapter (see "Installing an I/O expansion adapter" on page 705).

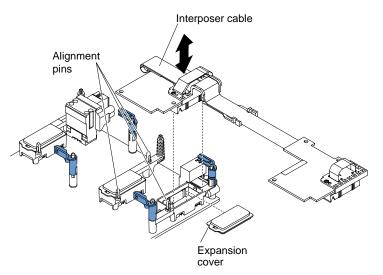
To install an interposer cable, complete the following steps:

- Step 1. Remove the cover (see "Removing the compute node cover" on page 676).
- Step 2. Locate the interposer connector (see "System-board connectors" on page 17).

- Step 3. If an I/O expansion adapter is installed over the interposer connector, remove it (see "Removing an I/O expansion adapter" on page 704).
- Step 4. Touch the static-protective package that contains the interposer cable to any *unpainted* metal surface on the Flex System chassis or any *unpainted* metal surface on any other grounded rack component; then, remove the interposer cable from the package.

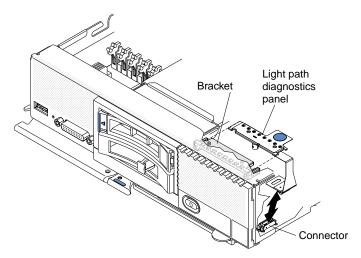
To install a light path diagnostics panel, complete the following steps.

Step 1. Remove the cover (see "Removing the compute node cover" on page 676).

- Step 2. Connect the cable on the system board.
- Step 3. Align the light path diagnostics panel with the bracket.
- Step 4. Press the light path diagnostics panel securely into the bracket.

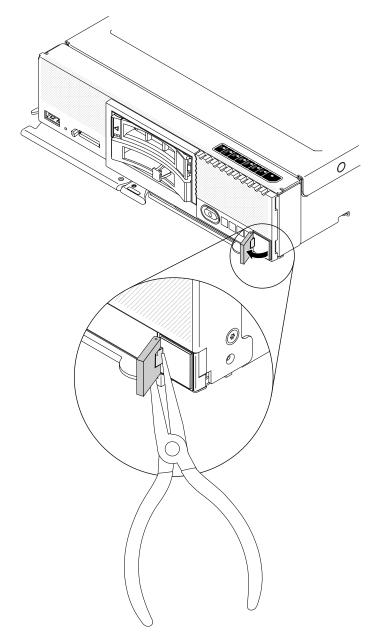
To remove the RFID tag, complete the following steps.

Step 1. If the RFID tag is still attached to its hinge, open the RFID tag.

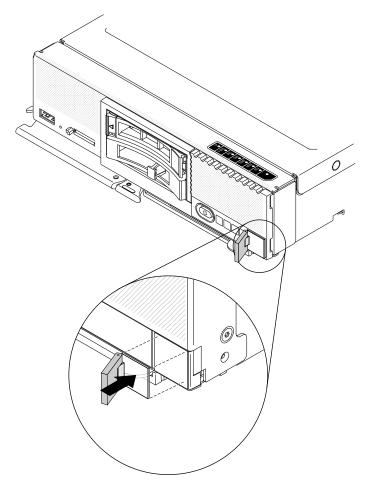
To install the RFID tag, complete the following steps.

- Step 1. Make sure that the surface you are installing the tag on is thoroughly clean and dry.
- Step 2. Open the RFID tag; then, remove the backing from the base of the RFID tag to expose the adhesive.
- Step 3. Position the RFID tag over the ID label on the front panel of the compute node.
- Step 4. Press the RFID tag securely against the bezel and hold firmly in place for 30 seconds.

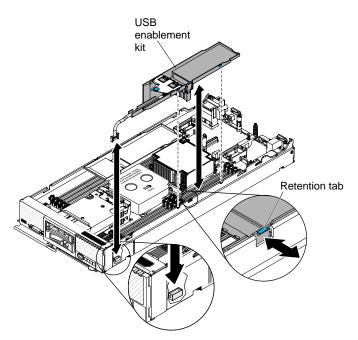
To remove the USB enablement kit, complete the following steps.

- Step 1. Remove the cover (see "Removing the compute node cover" on page 676).
- Step 2. Remove any USB flash drives that are installed in the USB connectors (see "Removing the USB flash drive" on page 712).
- Step 3. Disconnect the USB cable from the system board.
- Step 4. Release the retention tab from the side of the chassis and remove the USB enablement kit from the compute node.
- Step 5. Install an air baffle over the DIMM connectors.

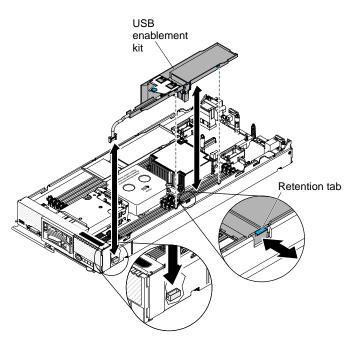
To install the USB enablement kit, complete the following steps:

- Step 1. Remove the cover (see "Removing the compute node cover" on page 676).
- Step 2. Remove the air baffle next to the USB connector.
- Step 3. Install the USB enablement kit over the DIMM connectors.
- Step 4. Press the retention tab into the matching notch in the chassis to secure the kit.
- Step 5. Locate the USB connector on the system board (see "System-board connectors" on page 17).
- Step 6. Connect the USB cable to the USB connector on the system board.
- Step 7. Install any USB flash drives in the connectors (see "Installing the USB flash drive" on page 713).

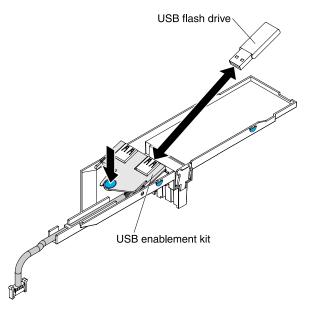
To remove the USB flash drive, complete the following steps.

- Step 1. Remove the cover (see "Removing the compute node cover" on page 676).
- Step 2. Press the USB enablement kit to access the USB flash drive connectors.
- Step 3. Pull the USB flash drive out of the connector.

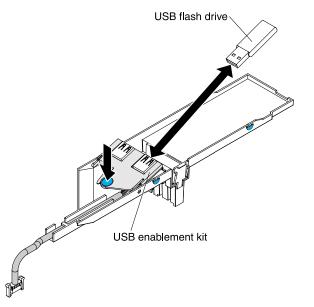
To install the USB flash drive, complete the following steps.

- Step 1. Remove the cover (see "Removing the compute node cover" on page 676).
- Step 2. Press on the USB enablement kit to access the USB flash drive connectors.
- Step 3. Push the USB flash drive into the connector.

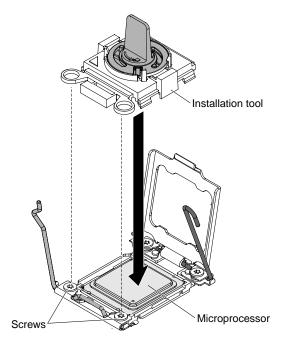
b. Align the installation tool with the screws, as shown in the following graphic, and lower the installation tool on the microprocessor. The installation tool rests flush on the socket only when it is aligned correctly.

c. Remove the microprocessor using the installation tool. Gently twist the handle of the installation tool clockwise until it locks in the "H" or "L" position, depending on the size of microprocessor, and then lift the microprocessor out of the socket.
